# **GEO**

### **Study on the Feasibility of the Production of Clay Tiles for Floors and Roofs in the Rupununi**

**Prepared by:  
Mauricio Pimentel**

**November 28, 2000**

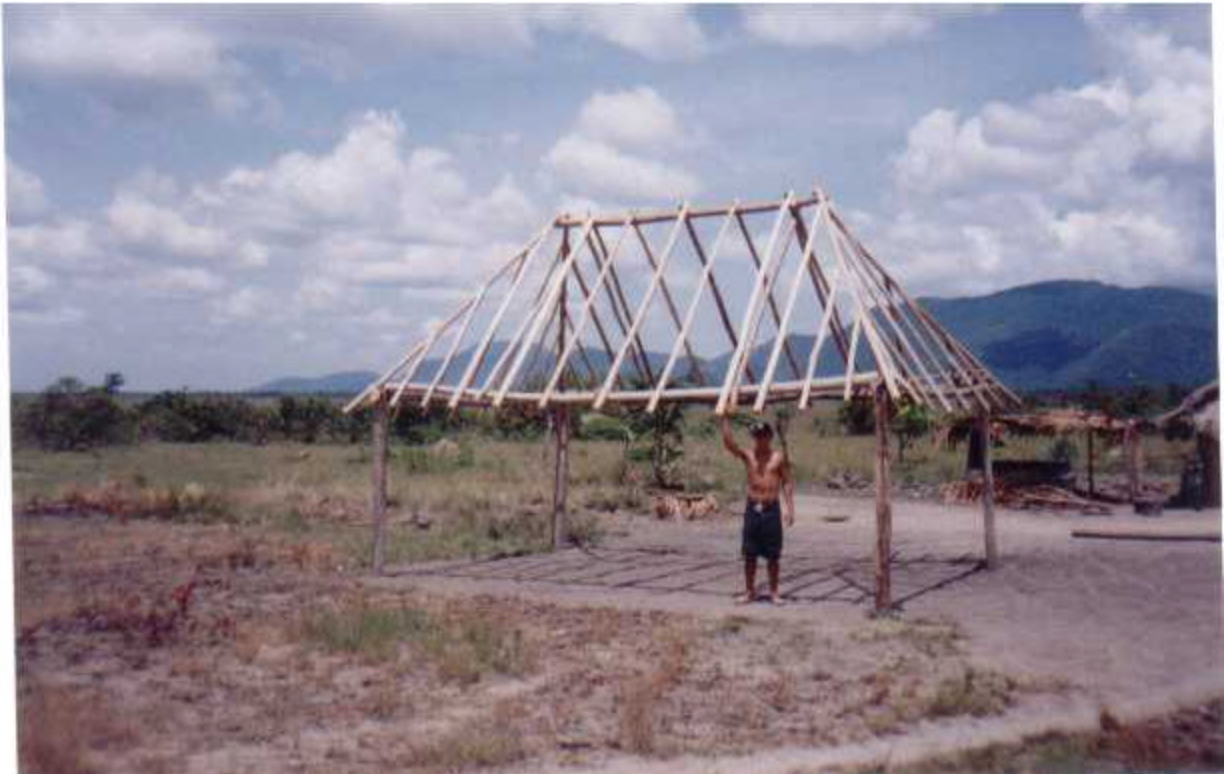
**Exhibit 1**

- 1) The degree of slope should not be greater than 30 degrees, and in most cases, that figure is 75 degrees (see roof structure in Exhibit 1).
- 2) The support pillars are of a small diameter and distances between rafters are random and generally greater than is recommended.

The following are the suggested solutions for the above problems. Support pillars should be replaced and new roofing structures built. This procedure deserves attention, and each case should be studied individually. For example, the following relates to the modification of the roof of a house measuring 3.5 meters by 5.0 meters, which is a common dimension in the region. The cost of materials for the structure of such a roof is approximately US\$346.00 (wood plus nails). This assumes that each resident will make the modifications himself, and that the wood will be purchased in Lethem, where the wood comes from lumberyards. If there is good-quality wood in the region, the pillars could be of round wood, and this would reduce the roof replacement cost.

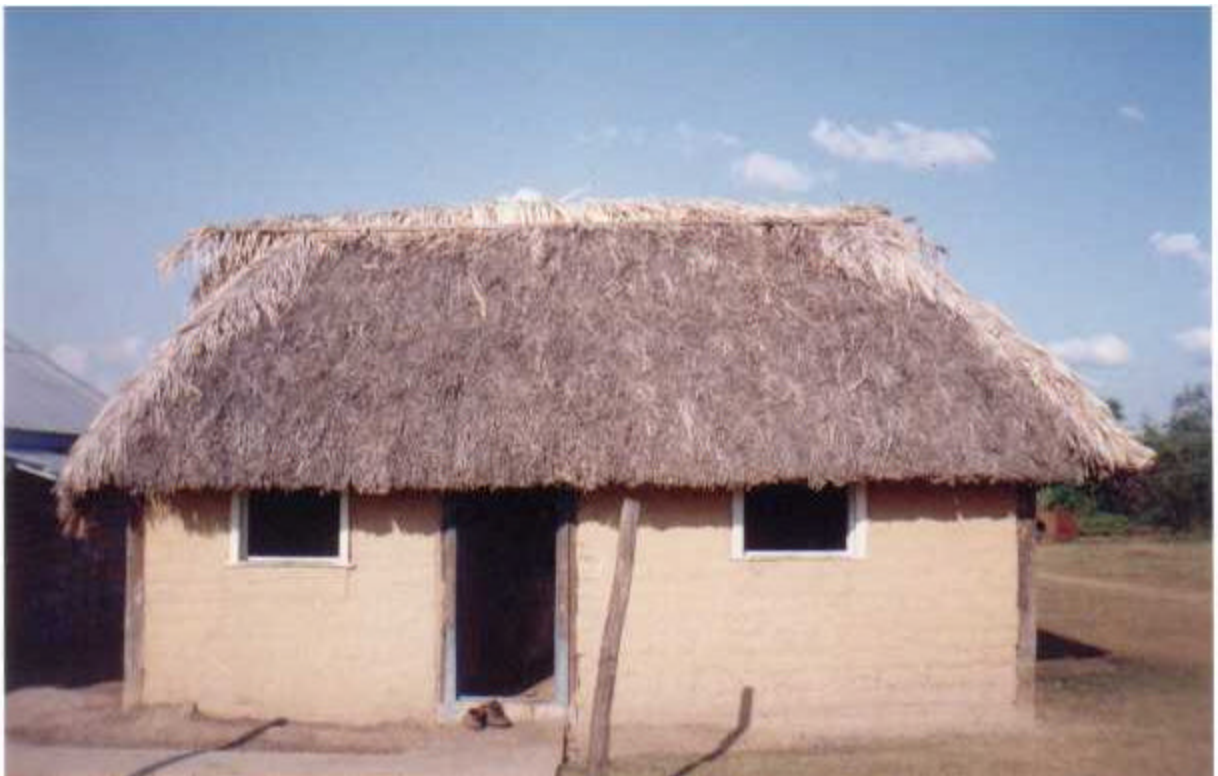
**Exhibit 2**

Exhibit 2 demonstrates the typical indigenous construction style.

The construction method employed for construction of local residences does not permit the use of clay tiles for two basic reasons:
